Manhole Inspection Summary

Manhole # S41UU_021MH

Insp Date: **2/13/07 11:09 AM**

Location Address: **1450 GORSUCH AVE**

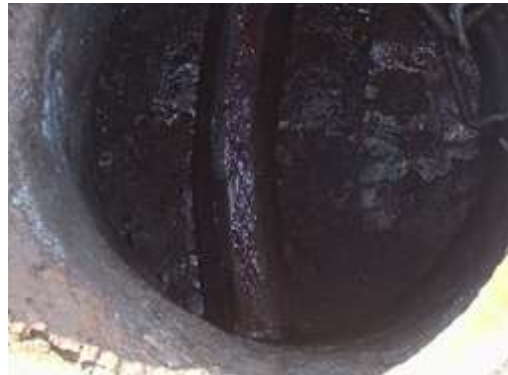
Top View

Corroded and missing steps. Evidence of surcharge - Bench debris.

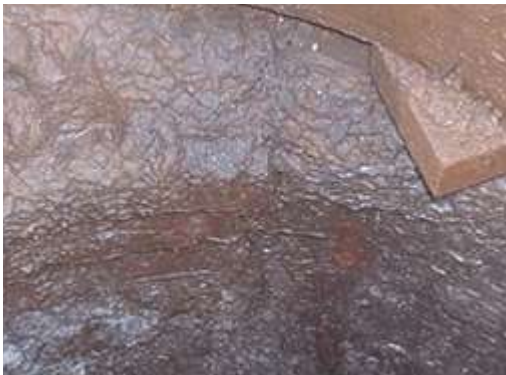
Defect

Frame Offset: **3** (in.) Condition: ☐ Sound ☐ Cracked ☒ **Leaks**

Condition: ☐ Sound ☐ Cracked ☐ Root Intrusion ☒ **Loose Brick** ☒ **Deteriorated**

Infiltration: ☐ None ☒ **Joint** ☐ Cracks ☐ Mortar ☐ Roots ☒ **Wall**

Frame leaks. Frame offset. Adjustment deterioration, loose brick and infiltration.

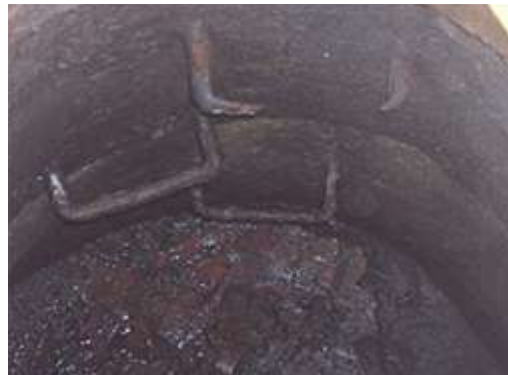
Defect

Steps Count: **3** Missing: **1** ☒ **Corroded**

Corroded and missing steps.

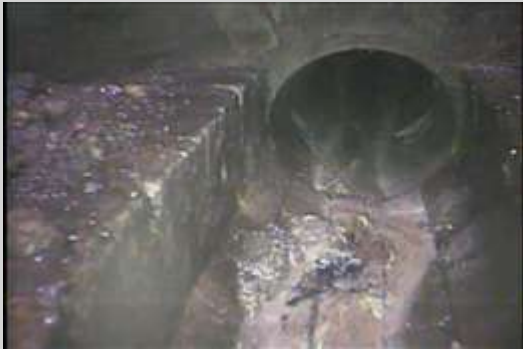
8 in. Circular Gravity Sewer Pipe Out @ 12 O'Clock

Pipe Material: **Clay** ☐ Pipe Lined

Invert Depth: **7.29** (ft.) Flow Characteristics: **Slow**

Infiltration: **None** Pipe Seal Cond: **Unknown**

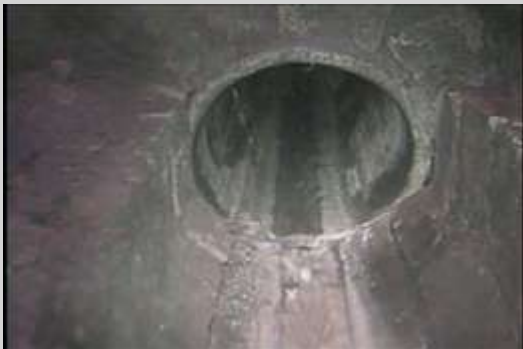
8 in. Circular Gravity Sewer Pipe In @ 5 O'Clock

Pipe Material: **Clay** ☐ Pipe Lined

Invert Depth: **7.04** (ft.) Flow Characteristics: **Slow**

Infiltration: **None** Pipe Seal Cond: **Unknown**
